**FONDI SHQIPTAR
I ZHVILLIMIT**

ENVIRONMENTAL IMPACT ASSESSMENT REPORT

**“IMPROVEMENT OF THE ROAD SEGMENT POÇEM
– VLLAHINË”**

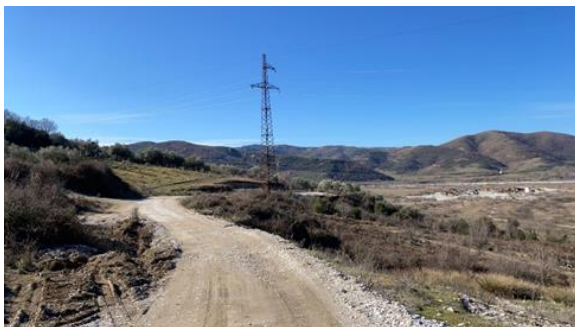
- Prog. km 2+400 – km 2+425

The route of the road in these segments is deformed in plan and in quota, giving level reductions which have been repaired during the time with occasional filling. Also the existing structures in these landslides are displaced as a result of the weak geological formation.

Also in the slopes of these segments, cracks and landslides are observed, for which an in-depth geological study will be made on the landslide plan and engineering measures will be taken to stabilize them.

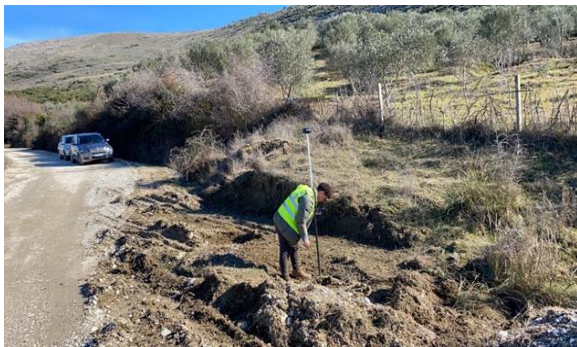
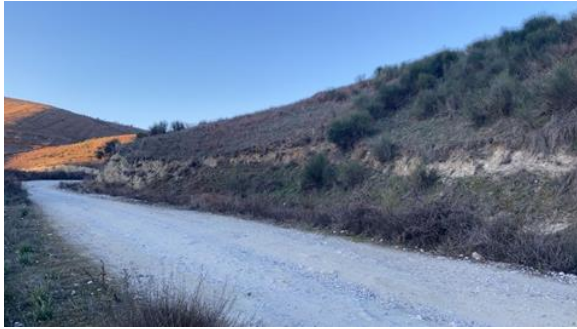
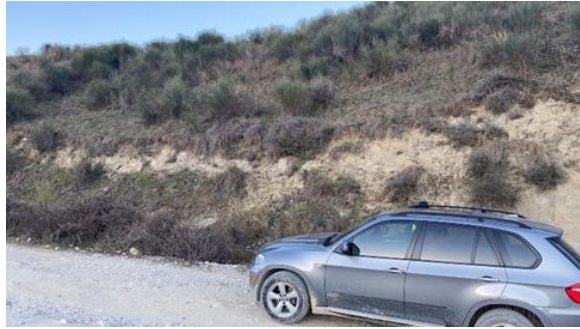
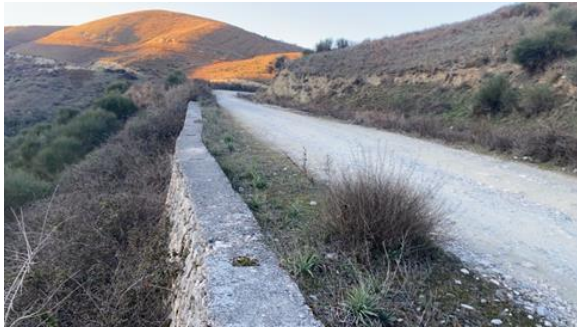
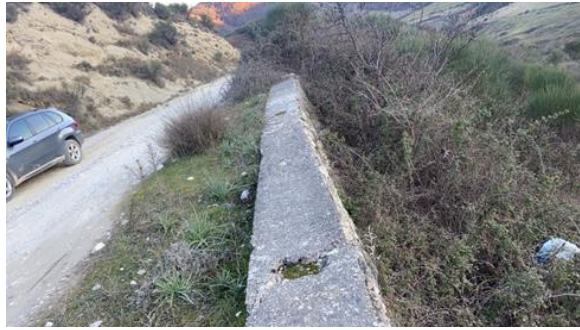
- Prog. 9+475 – km. 9+525

Pk. 379 – 381 / km. 9+475 – km. 9+525;

The total length of large slides is about 500 ml, for which engineering measures will be provided for stabilization based on the results obtained in the geological report.

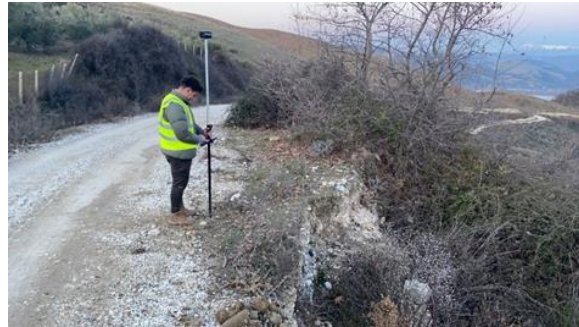
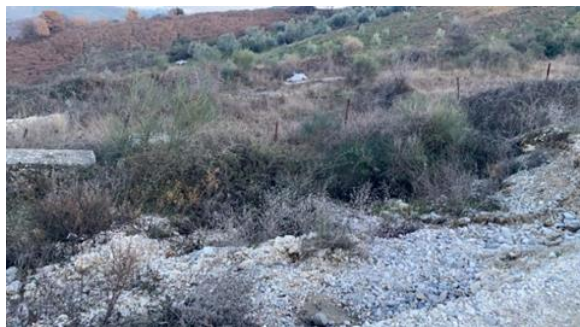
- Prog. km 10+775 – km. 10+825

Pk. 431 – 433 / km. 10+775 – km. 10+825;

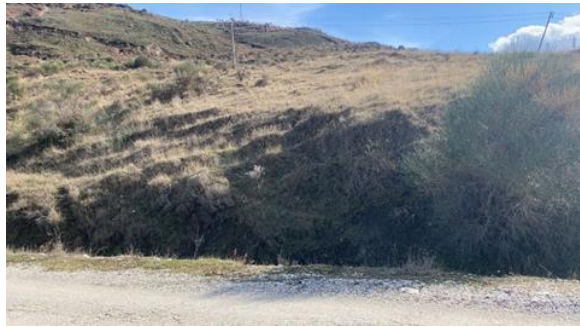
- Prog. km 12+375 – km 12+500

Pk. 495 – 500 / km. 12+375 – km. 12+500;

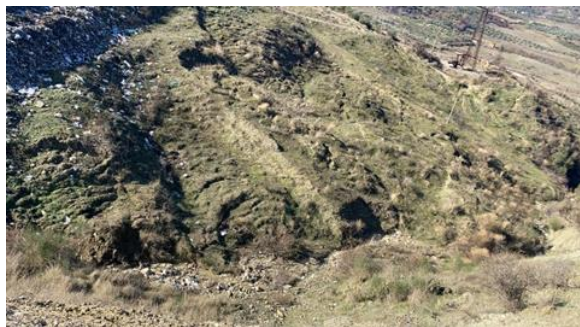
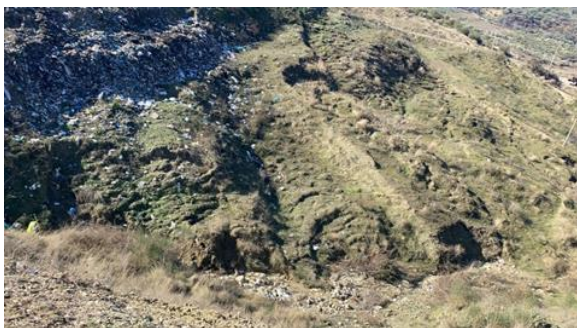
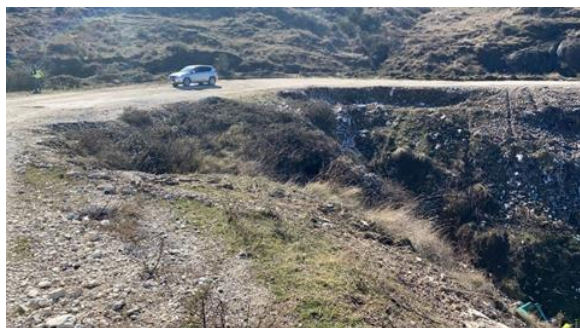
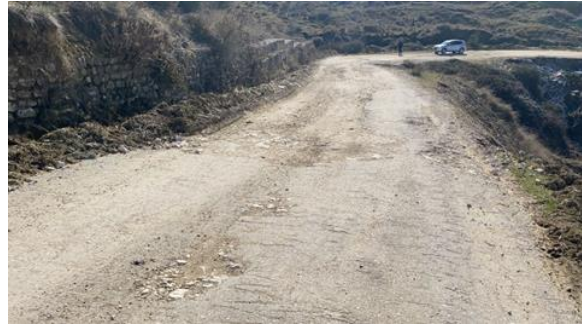
- Prog km 12+875 – km 13+150

Pk. 515-526 / km. 12+875 – km. 13+150; (segment which presents with major problems)

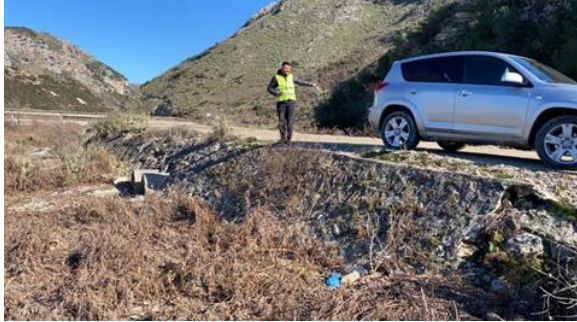
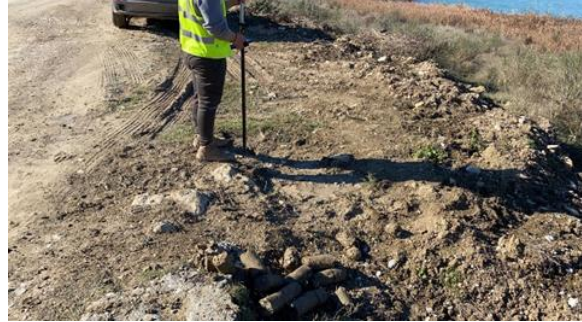
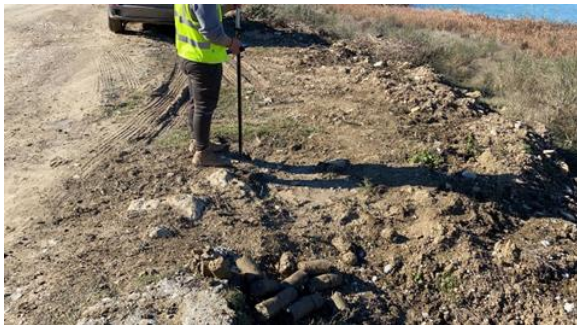
- Prog. km 3+950- km 4+175

Also, the road segment behind the bridge in the progressive km. 3 + 950 - km. 4 + 175, which also serves as a river embankment, the slope on the side of the river is covered with stone material and mortar of the time, but from the field inspection it results worn out as well as in certain segments even damaged

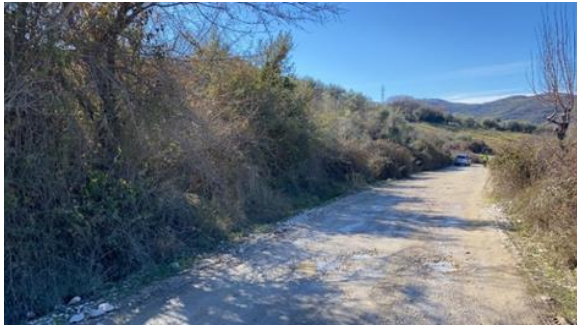
- Prog. km 2+300 – km 2+400

In addition to large landslides, in certain segments, damage has been identified in the form of smaller landslides, which are partly reinforced with retaining walls and partly not. In these segments are visible cracks in the slope in the form of slip as well as slight deformations of the road body in the quota and in the plan.

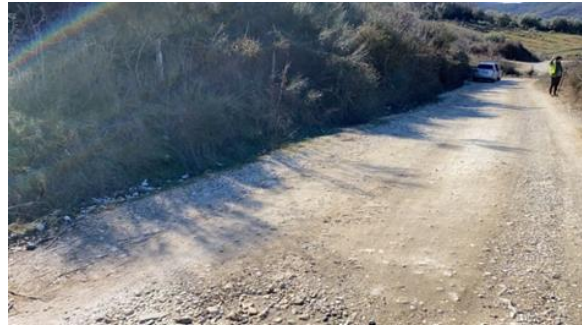
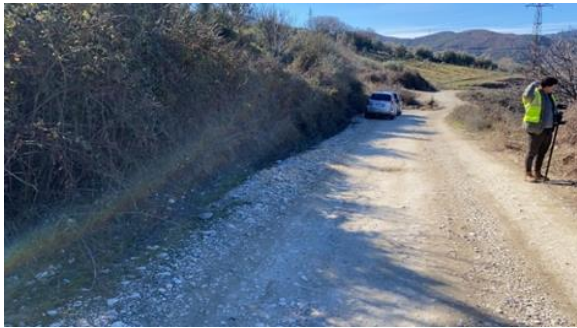
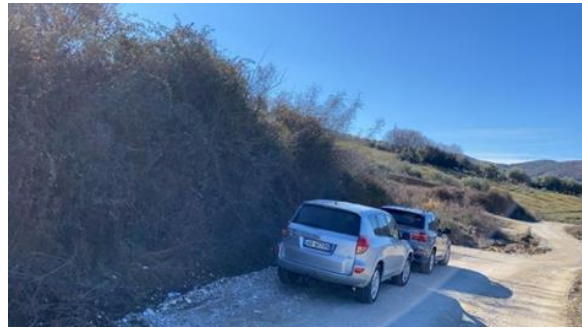
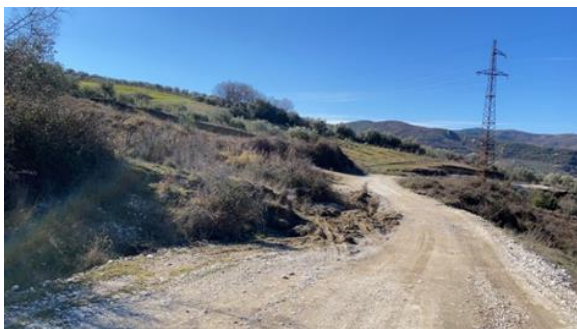
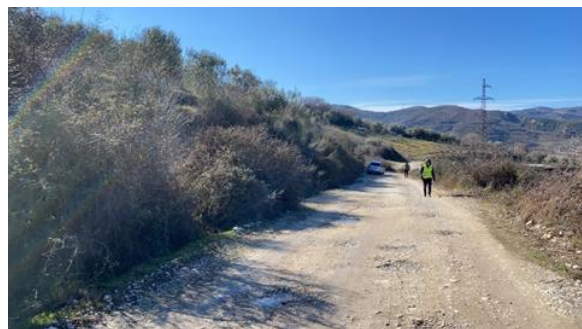
Prog. km 2+300 – km 2+400

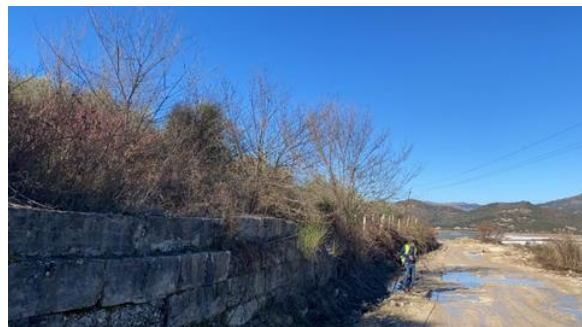
- Prog. km 5+500 – km 5+650

Prog. km 5+500 – km 5+650

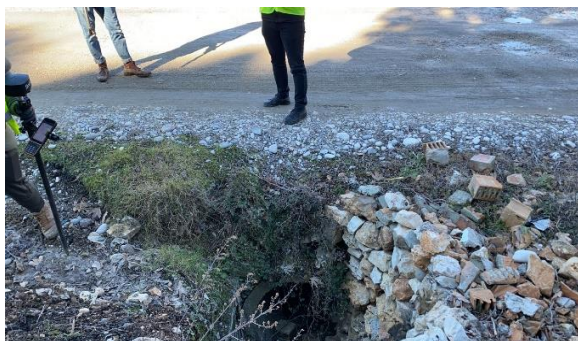
Pk. 30

The culverts are mainly Ø 800 in diameter, with manholes by drainage channels and portals supported by stone retaining walls 1 m wide and with a 80 cm concrete band at the top. The condition of most of these culverts is depreciated, out of order due to filling and internal damage. The manholes which are built with stone walls are totally out of order. Also in some cases in the retaining walls of the portals, the masonry is stable, does not present visible structural damage but their connecting concrete band is totally depreciated and for this there will be a detailed analysis on the solution to be proposed.

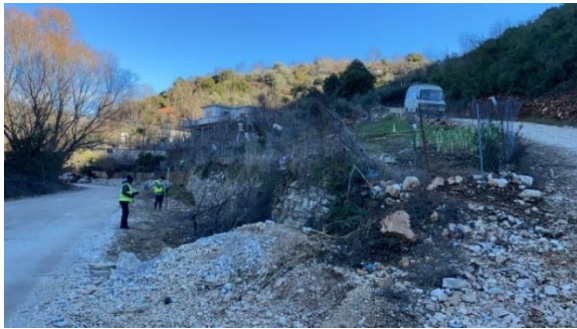
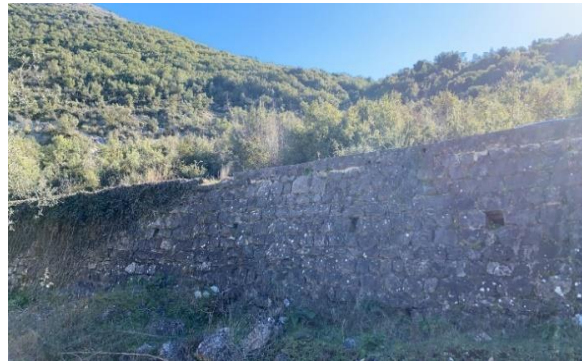
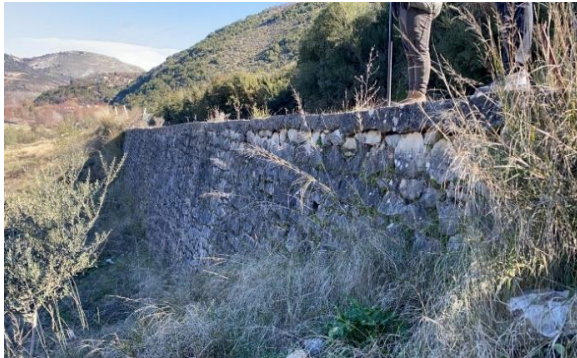
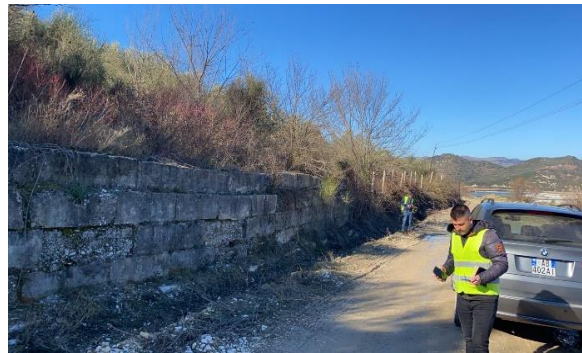
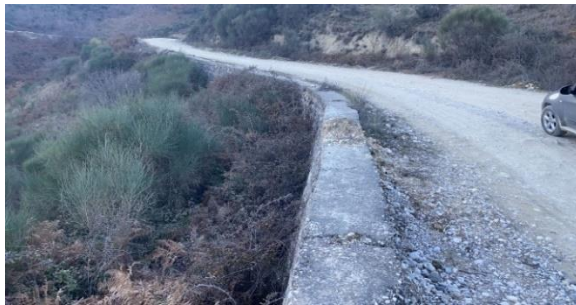
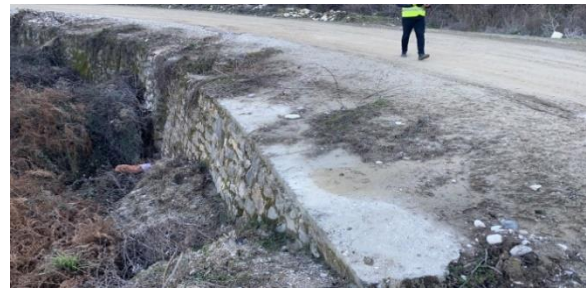
Retaining walls.

Retaining walls are all built of stone materials or concrete blocks and with a concrete connecting band on their head with a height ranging from 1 to 8 m. In two special cases we have a concrete retaining wall with a height of 3m. Their condition is mainly stable but their retention will be analyzed as the material used which is stone may present problems after the intervention. And for this there will be a reference photographic material (Annex A).

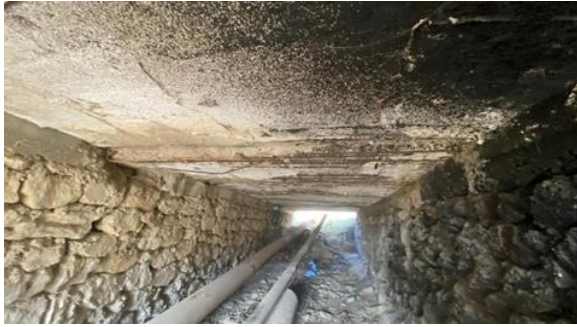
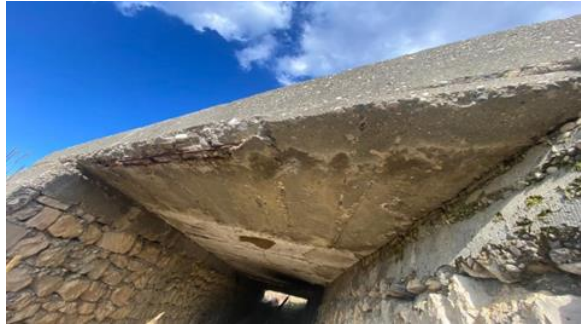
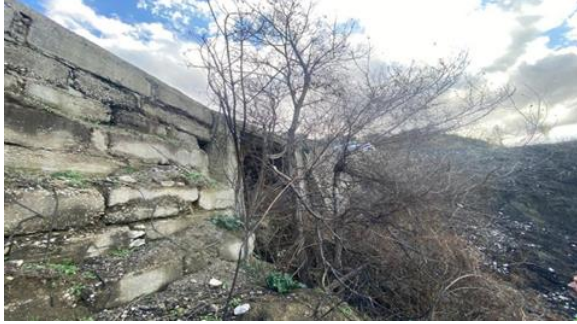
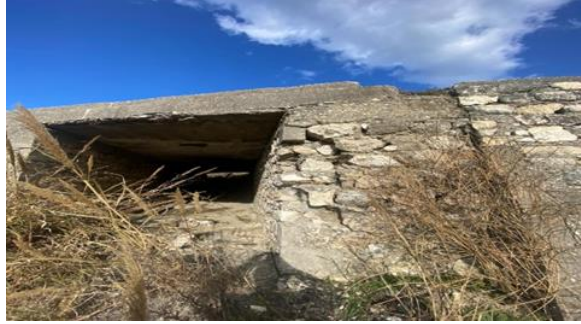
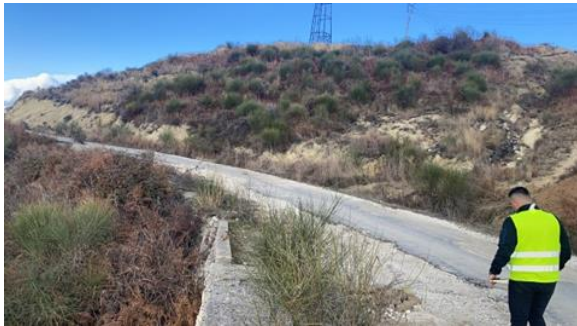
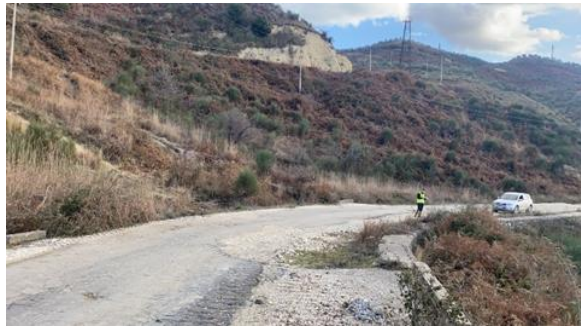
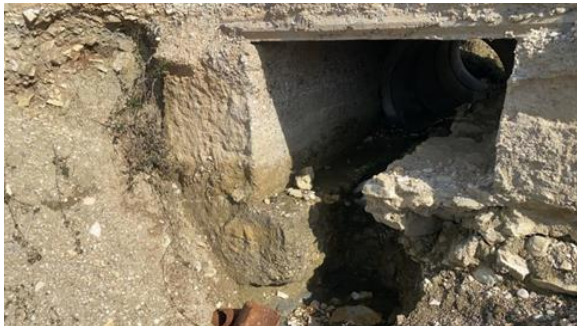
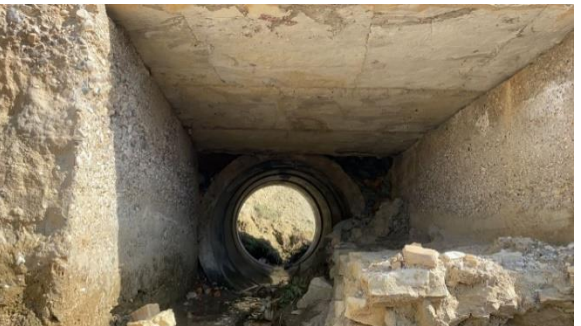
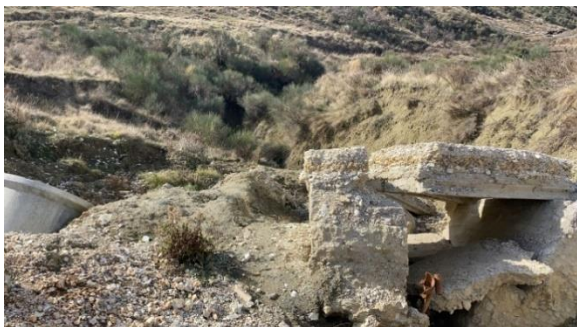
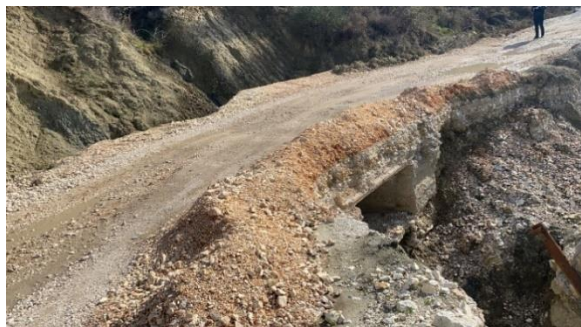
Also, the existing condition of the bridge over the Vjosa River in the progressive km.3 + 575 - km.3 + 750 is presented without structural problems but the depreciation of the concrete side railings is noticed. The bridge with Hd = 165m, has a total width of 8 m, where the passing width is 6 m and is limited by concrete pavements with a width of 1 m on both sides. The concrete layer of the pavement is consumed and it is ascertained that the iron of the pavement concrete is corroded, as well as the damages of some camps of the bridge railings, which are reinforced concrete.

Attached photos taken during the inspection:

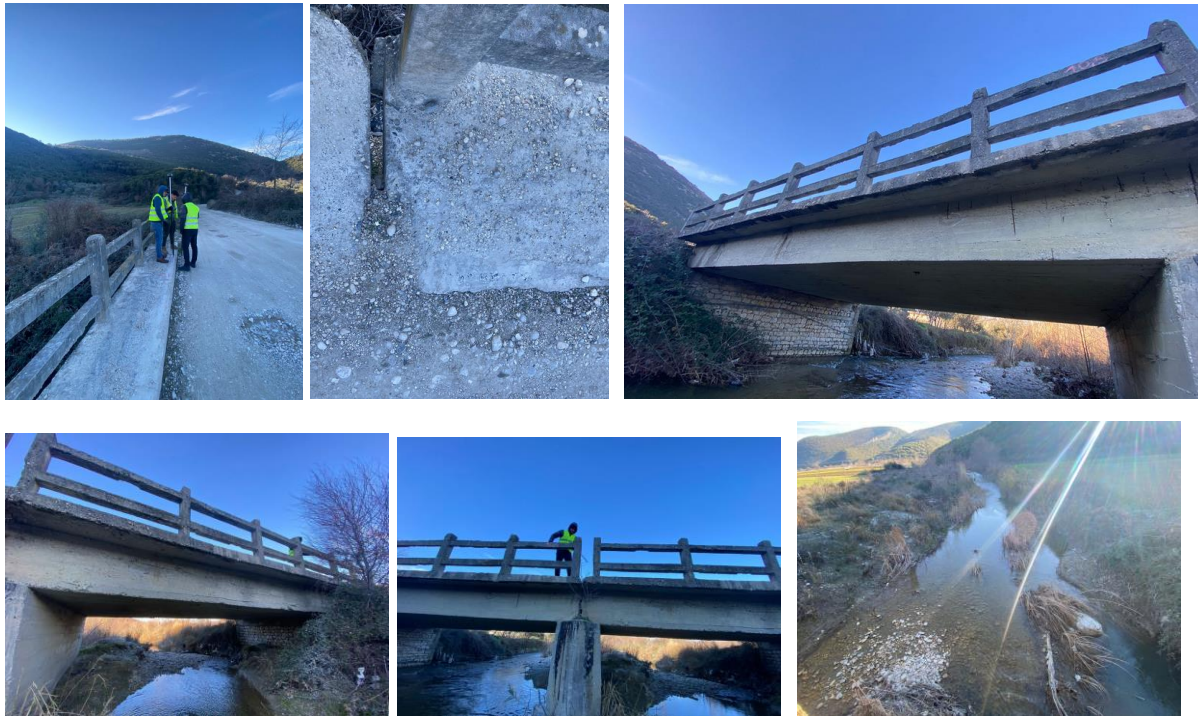
Ura ne prog. 0+250 km.

Also in this road segment there are works of art such as small bridges (type culvert / box), which are presented as follows. The foundations of these bridges are built with stone walls,

concrete blocks or aerated concrete. The supporting shoulders of the bridges are built with stone walls or concrete blocks and with a concrete connecting band on top. Depreciation consists of damage to their supporting foundations which are made of stone wall material with concrete band on top of them. The cover part is with pre-prepared reinforced concrete slabs in the form of panels which in some cases turn out to be unbound, and also corroded iron is noticed. From the ascertainment it results that these structures appear depreciated and damaged and concretely their foundations in some cases are uncovered by erosion and the masonry is damaged. There are also cases where there is a level reduction of the base. For all these structures we will present in this report the descriptive photographic material of their condition.
